REPORT NO: NAWCADPAX/TR-2002/94

### **TESTING CONDUCTED ON WALL-HANGING TROOP SEATS**

14. ABSTRACT  This report presents the data collected during testing conducted at NAWCAD Patuxent River, Maryland. The tests conducted were static load tests and were conducted on wall-hanging troop seats. Four seats were tested, all of them being of the three-man configuration. Tests were conducted for the Defense Logistics Agency and the Air Force. All photographs and data collected from the testing are contained herein.

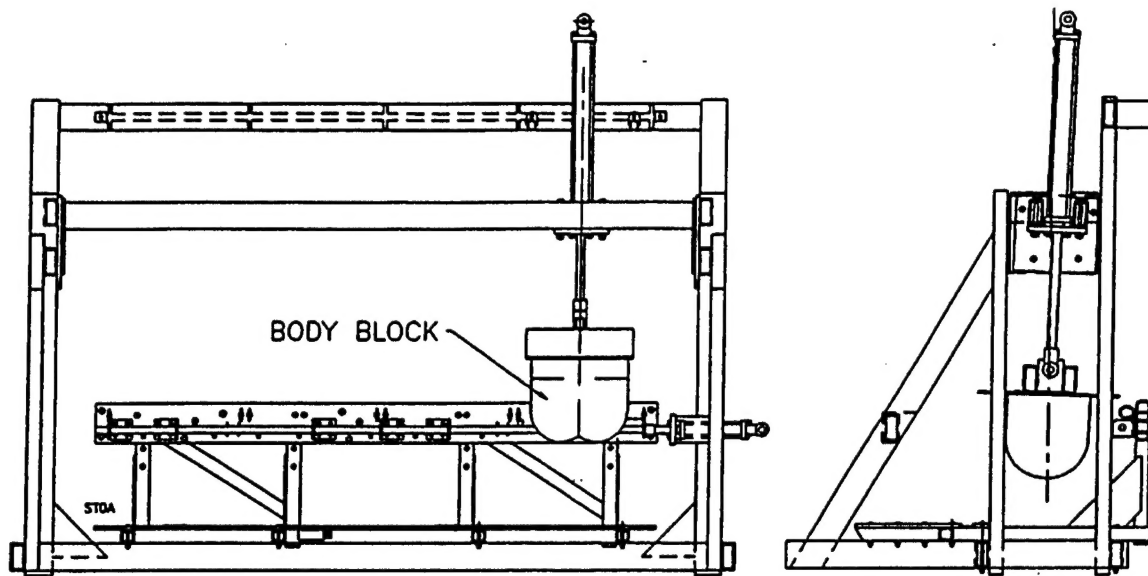
Figure 1: Front and side views of static tester. Configuration shown is for testing a one-man seat with a body block. Body block was not used for this testing.

The design of the Static Test Fixture was a result of interior surveys of the C-130, C-141, and KC-135 aircraft. The fixture was designed to simulate the seat attachment points for the aircraft and provide a stable framework from which the desired testing loads could be consistently applied. The structure was designed to measure loads from the seat bottom or back as well as the side loads. The design of the Static Test Fixture also allowed for tensile strength of legs to be tested. A front and side view of the structure is shown in figure 1. The position of the hydraulic cylinder during a back test is shown in figure 2. Figure 3 shows the three-man pressure foot used during the back testing. This pressure foot was also used for the bottom and side testing.

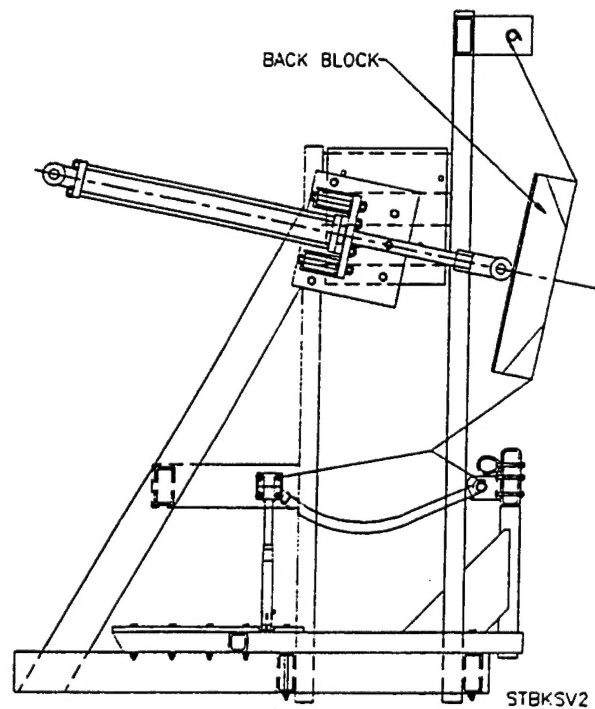
Figure 2: Position of Pressure Foot during Back Load Test

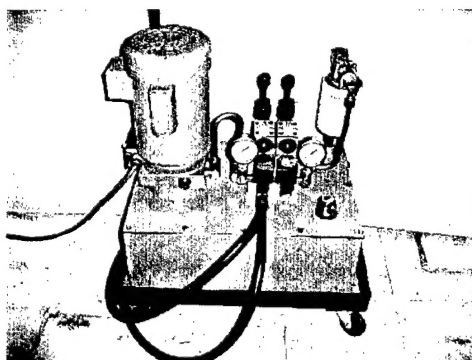
Figure 4: Front view of pump which controls the hydraulic cylinder that applies bottom and back force, as well as leg test. Pump that applies side load looks the same.

Hydraulic pumps drive the cylinders. The pumps were ordered through Bearings and Drives, Inc., Asheville, North Carolina, and were manufactured by Gibson Machines. The pumps use Parker Hydraulic Valves for controlling the amount of pressure and direction of the load. The hydraulic cylinders are loaded by the pumps at a maximum rate of 20 lb/sec. The Parker Hydraulic Valves are controlled by hand. Figure 4 shows the hydraulic pump used for the static testing.

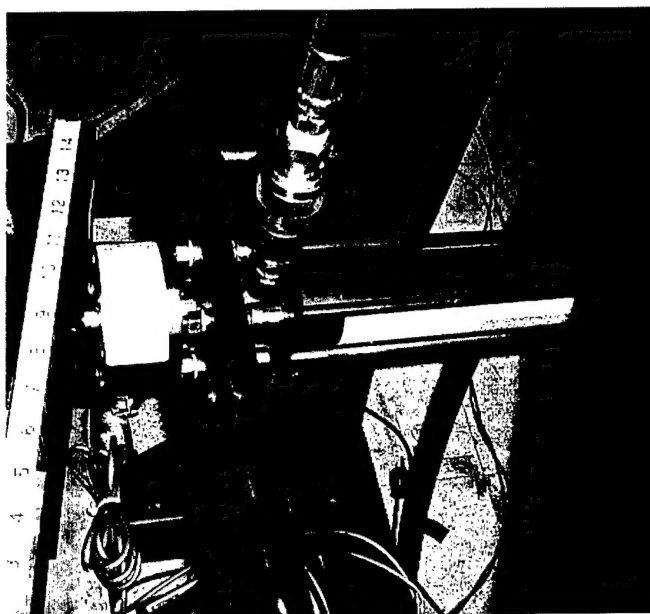
Figure 5: Sensotec Load Cell on Side Hydraulic Cylinder

Two Sensotec load cells are used to measure the amount of pressure applied by the pressure foot. The load cell used for applying the side load is shown below in figure 5. The load cell used for measuring the bottom and back loads as well as the leg test measure up to 10,000 lb. The load cell used for the side loads measures 5,000 lb. For both load cells, compression is considered positive and tensile is considered negative. Both load cells are calibrated prior to each test to assure that all data obtained is accurate. The load cells are connected to two strain gauge amplifier/display units, which are connected to a Portable Data Acquisition System (PDAS)-3. The PDAS and Sensotec load cells were purchased from *IndustroLogic*, Inc. in St. Charles, Montana. Data are collected at the rate of 50 samples per second. The PDAS is connected to a laptop, which downloads the data after the test is complete. Data are saved in an ASCII format, which is converted into Excel files. These Excel files can be used for data analysis.

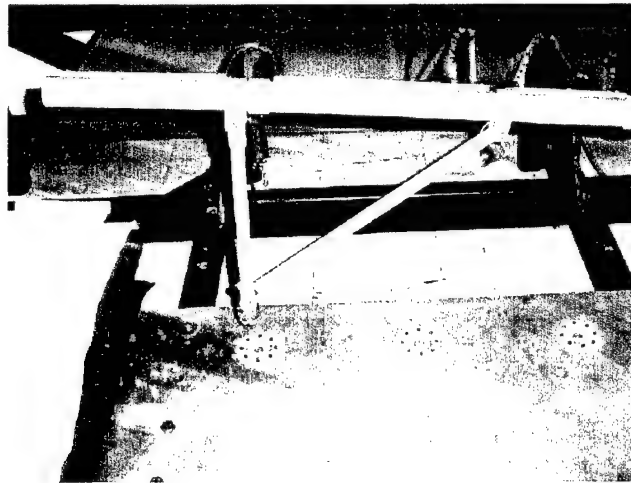
Figure 6: Right Leg and Distance from Floor Plate

The first test conducted was a back test. Prior to attaching the seat to the Static Test Fixture, the weight of the seat was exactly 5 lb. This test used the three-man pressure foot. The proof load of 1,200 lb was first applied for 60 sec. Prior to reaching the proof load, at approximately 914 lb, the right leg of the seat came free from the bottom plate. Since there was no ripping or failure of the legs or spreader bar, the test continued. Other than the leg coming free, there was no deformation of the seat and no failure. Next, the ultimate load of 1,800 lb was applied. Prior to reaching the ultimate load, at 1,754 lb, the fabric from under the front tube on the left side came free. The fabric did not rip, and the screws did not come loose. The left most tiedown hook came free from the upper attachment, but did not deform or fail. Photographs of the failure are shown in figures 6 through 9. The graph created from the downloaded data is shown below in figure 10. All still photographs that were taken are shown in appendix B.

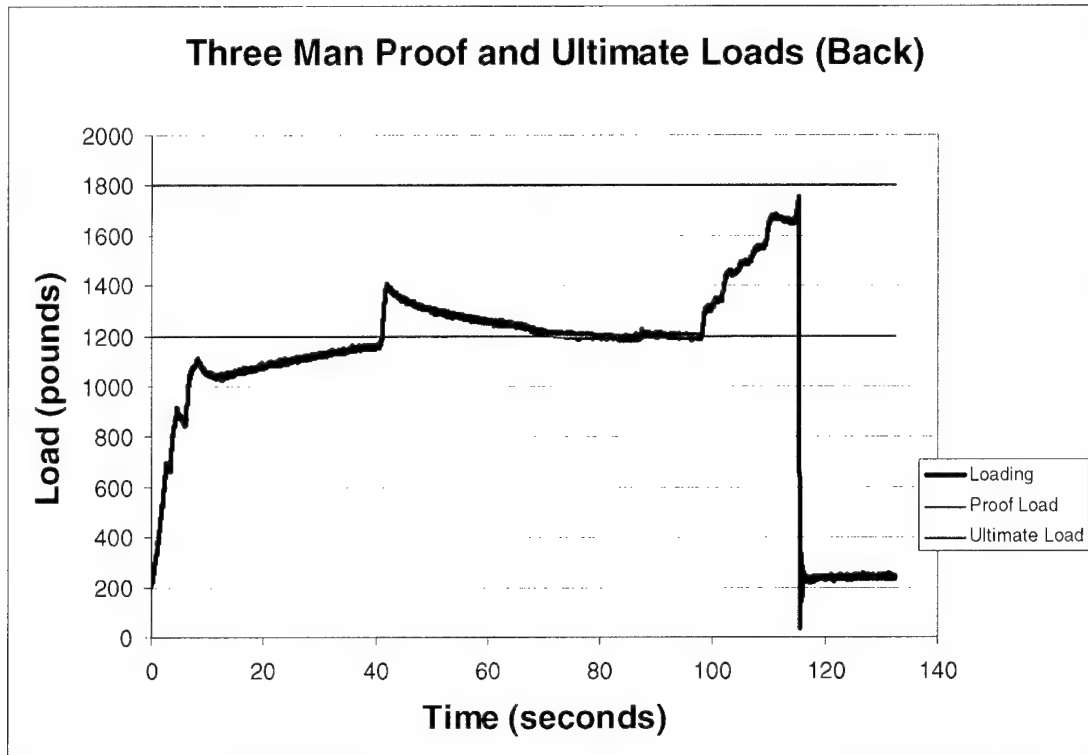
Figure 10: Data Collected during Back Loading Test

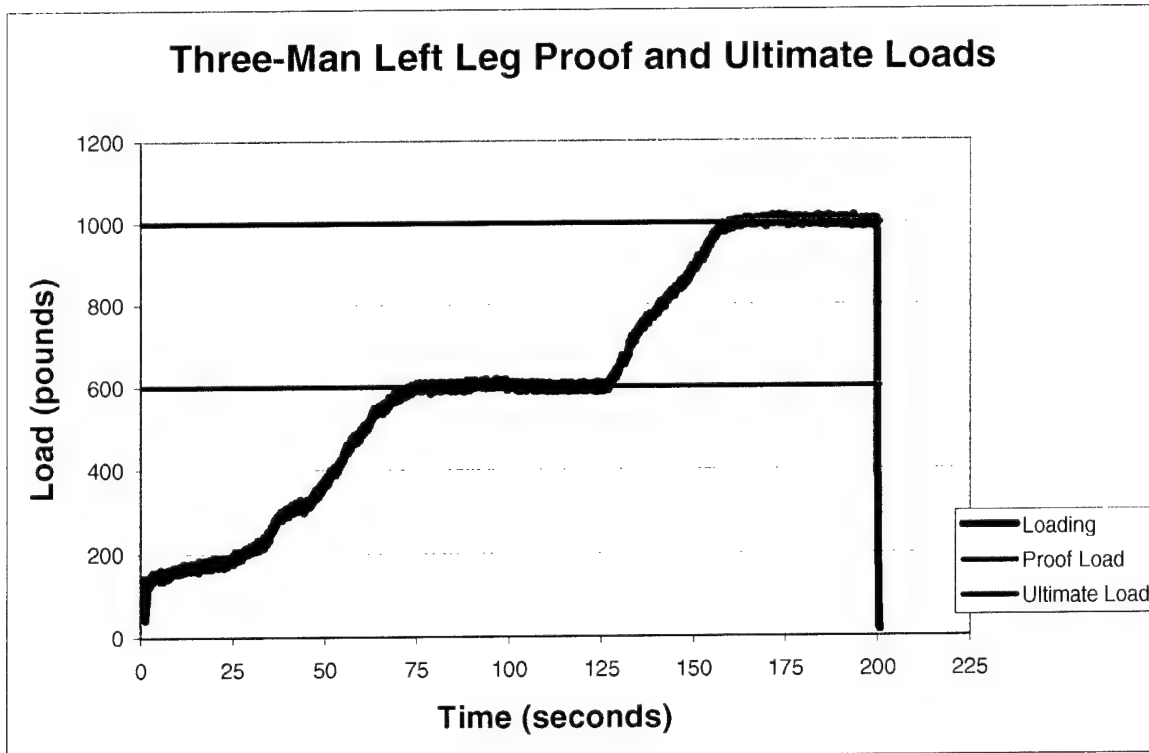
Figure 11: Data Collected during Testing of Left Leg

After examination of the right leg of the first seat tested, no damage was found on the bottom plate or on the locking mechanism of the leg. It was decided to test the legs next to ascertain that the legs could withstand the proof and ultimate loads and to see if the legs would pull apart from the bottom plate again. This involved removing both legs from the Newgard seat. The legs each weighed 0.75 lb. The left leg was tested first. The proof load of 600 lb was first applied and held for 60 sec. No deformation of the leg was seen. The ultimate load of 1,000 lb was then applied and held for 60 sec. Again, no deformation of the leg was seen. After testing, the leg was removed and measured. No elongation of the leg had occurred during testing, and all locking devices at the bottom of the leg were undamaged. The graph created from the downloaded data is shown below in figure 11. The still photographs taken are available in appendix B. The right leg was tested next. The procedure followed for the left leg was followed for the right leg. The right leg did not deform or fail. The graph created from the downloaded data is shown in figure 12, and all still photographs are available in appendix B.

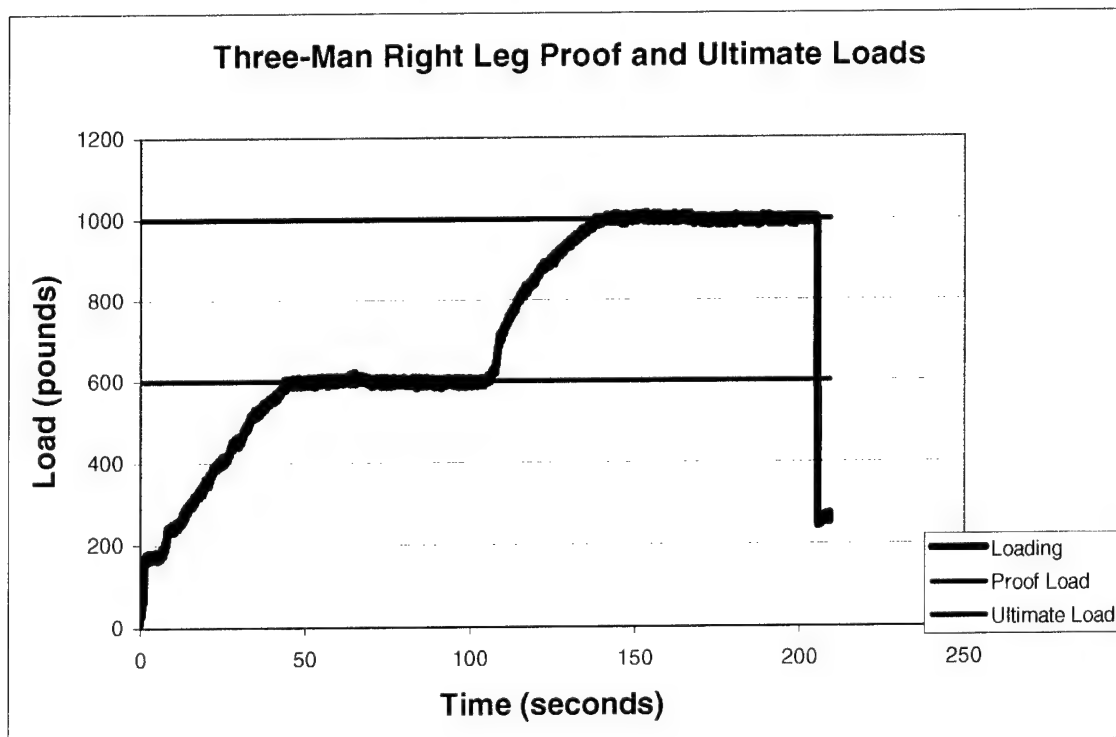
Figure 12: Data Collected during Testing of Right Leg

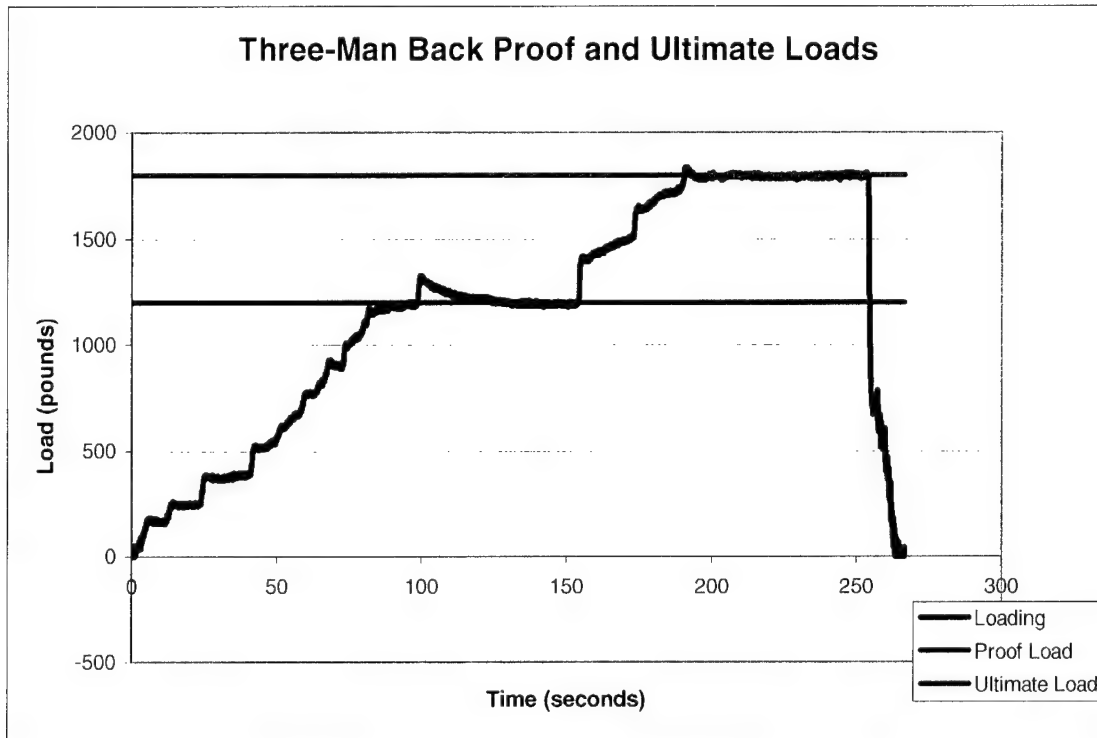
Figure 13: Data Collected during Testing of Seat Back

The second back test was conducted using a new seat. LT Tim Skaar was in attendance. Prior to attaching the seat to the Static Test Fixture, the seat was weighed and the weight was measured to be 8 lb. This seat was 3 lb heavier than the first seat that was back-tested. This test again used the three-man pressure foot. The proof load of 1,200 lb was first applied for 60 sec. Then the ultimate load of 1,800 lb was applied. There were no failures during this test. The graph created from the downloaded data is shown below in figure 13. All still photographs taken are available in appendix B.

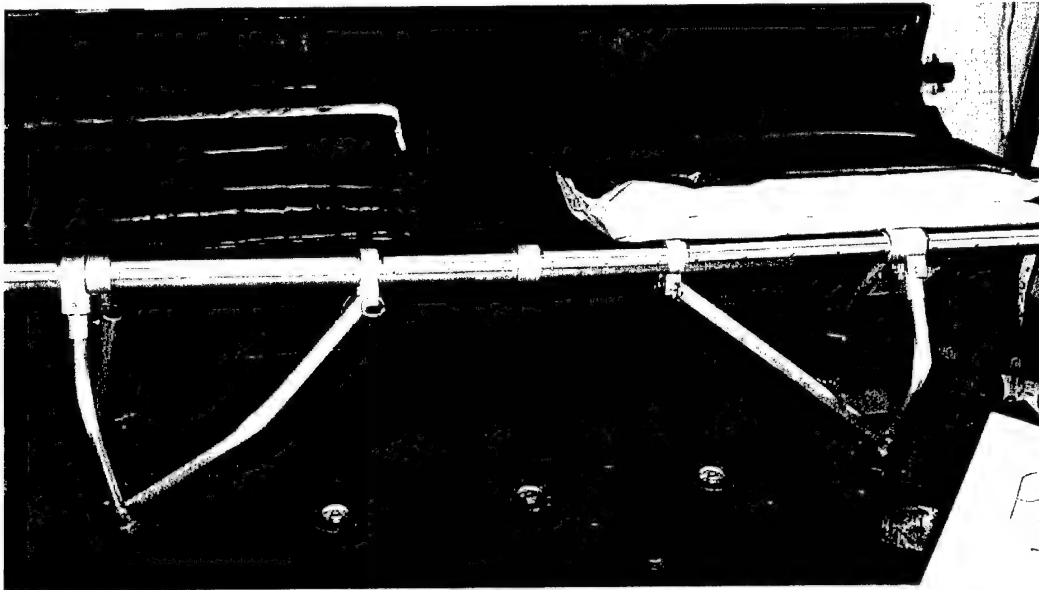
The bottom and side test was the last test conducted. LT Tim Skaar was on hand to witness this test. The seat was weighed prior to testing and weighed 8 lb. The Test Plan called for a proof load for the bottom to be 4,410 lb. The loading was reduced to 4,030 lb to account for the weight of the pressure foot and the weight of the sandbags. This is because the seat would see the total weight of 4,410 lb, while the digital readout would only show 4,030 lb. The bottom load was first applied to the seat and held for 60 sec. After 60 sec, the displacement of the front tubing was measured and the side proof load was calculated to be 450 lb. This load was applied and, when reached, the right spreader bar came loose from the rear bar where it was attached. After consulting with LT Skaar, this was not deemed a failure and the testing continued. After holding the side proof load for 60 sec, the bottom load was increased so that the ultimate load of 6,220 lb could be reached. Prior to reaching the ultimate load at 5,420 lb, the legs of the seat buckled and the left spreader bar came loose from the rear bar where it was attached. It was

determined that the seat no longer had load-bearing capability and the test was stopped. Photographs of the failures are shown below in figures 14 through 19. The graph created from the downloaded data is shown below in figure 20. All still photographs taken are available in appendix B.

Figure 14: Front View of Failure of Legs

The three-man wall-hanging troop seat does not meet the standards established in Military Standard 5804C. Because they do not meet this standard, they do not give adequate protection to the troops that have to sit in them. Therefore, it is recommended that the seat be redesigned or that a replacement for the seat be found.

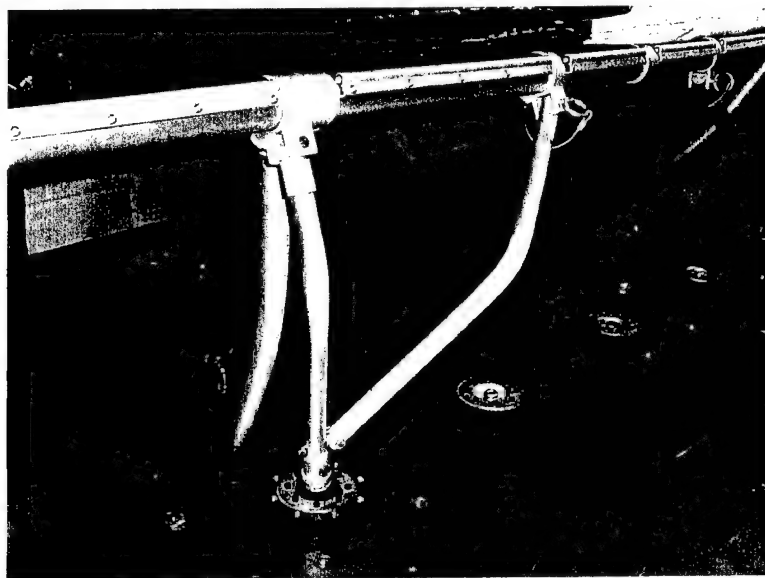
Figure 15: Closeup of Failure of Right Leg

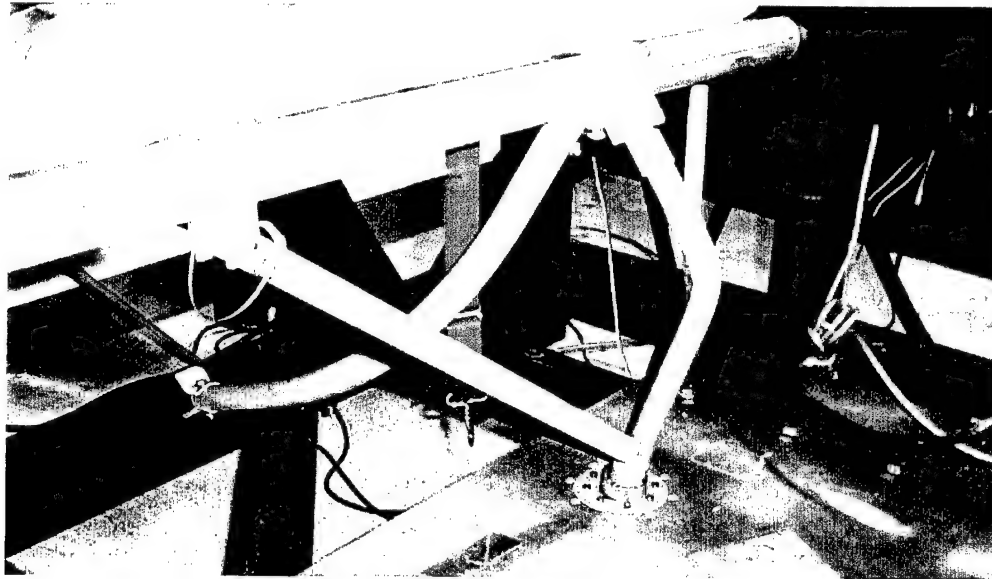
Figure 16: Closeup of Failure of Left Leg

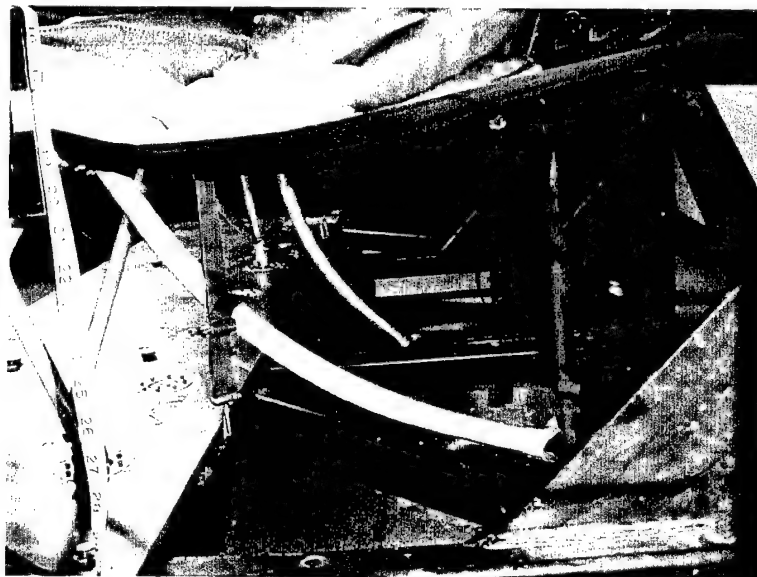
Figure 17: Spreader Bars from Side

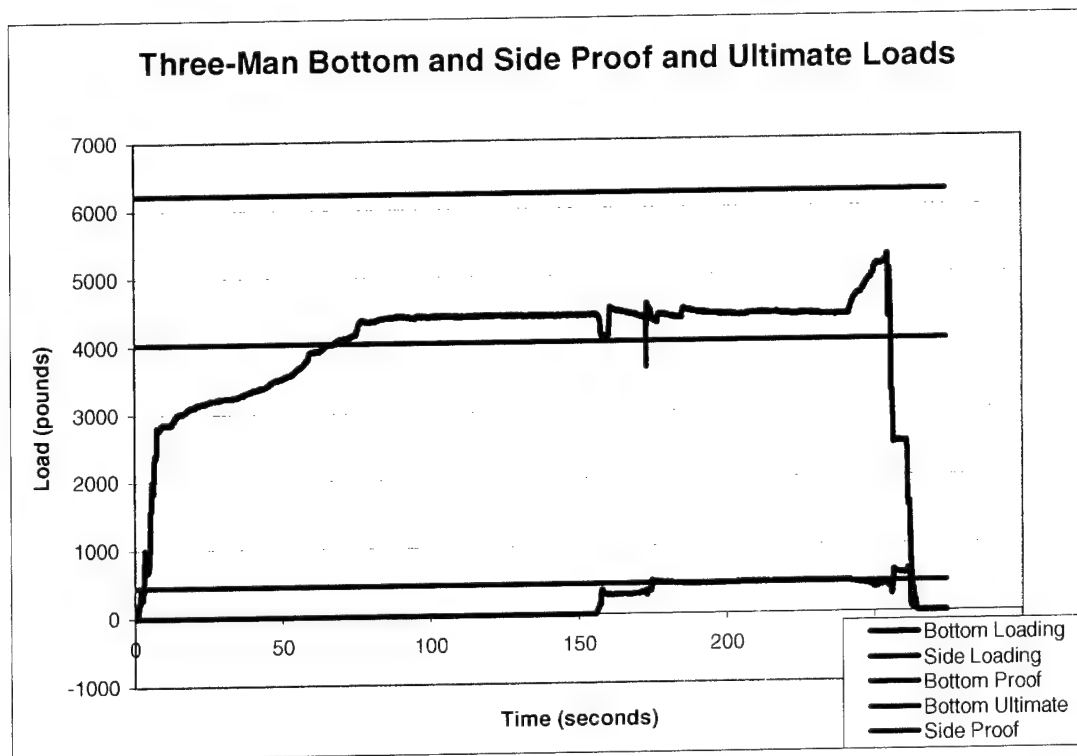
Figure 20: Data Collected during Testing of Seat Bottom and Side

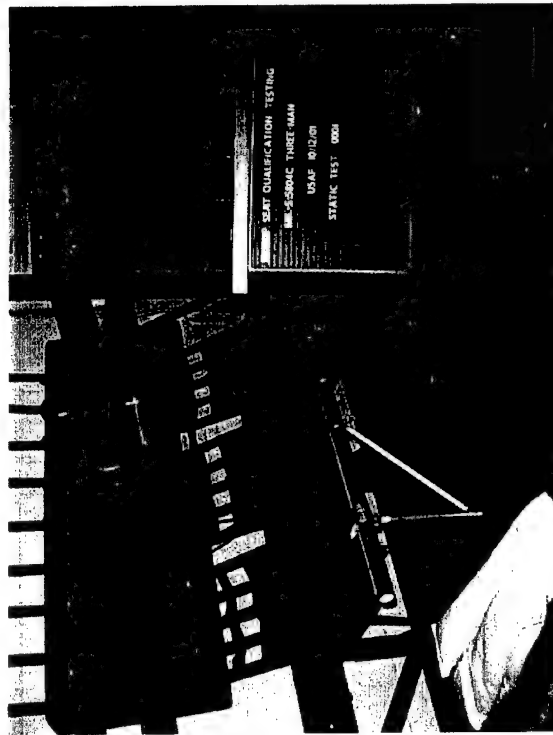
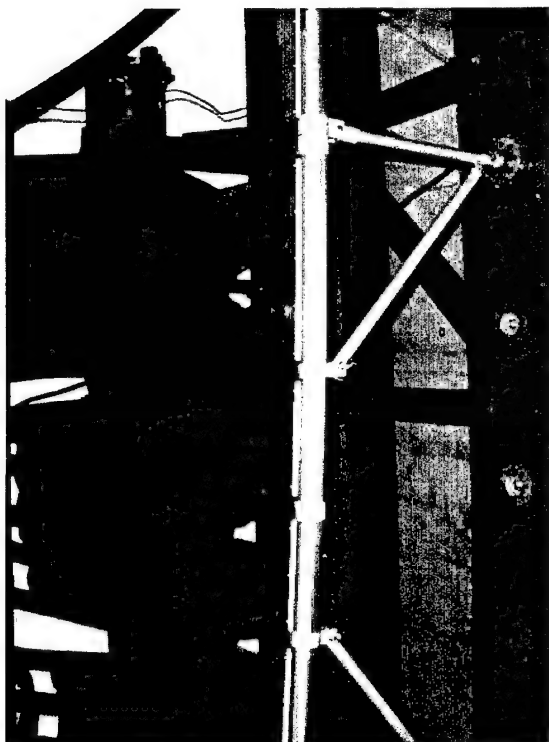
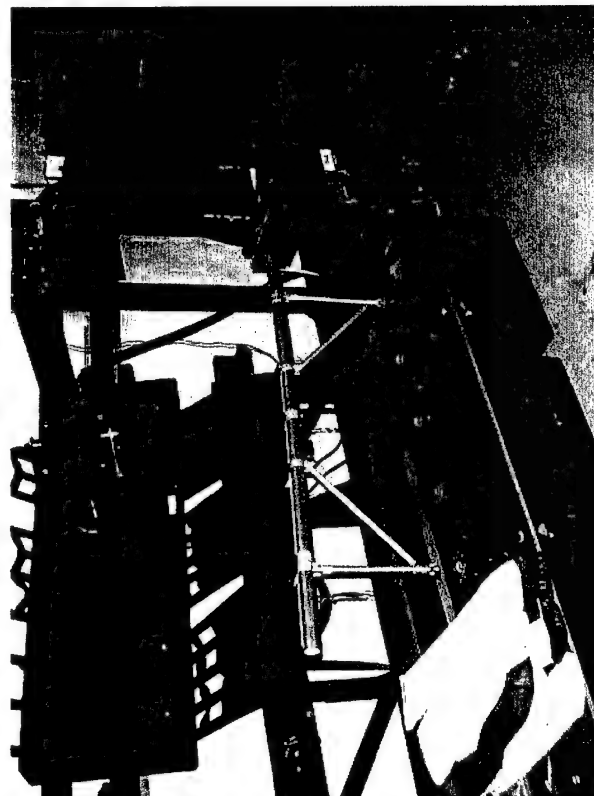
NOTES: At approximately 914 lb. the locking device on the right leg unlocked and allowed the right leg to come out of the fastening point. The leg was 6 in. off the floor plating. At 1,754 lb, the fabric came out from under the seat structure attaching screws. There were no tears or rips anywhere in the fabric. No other damage was done to the seat.

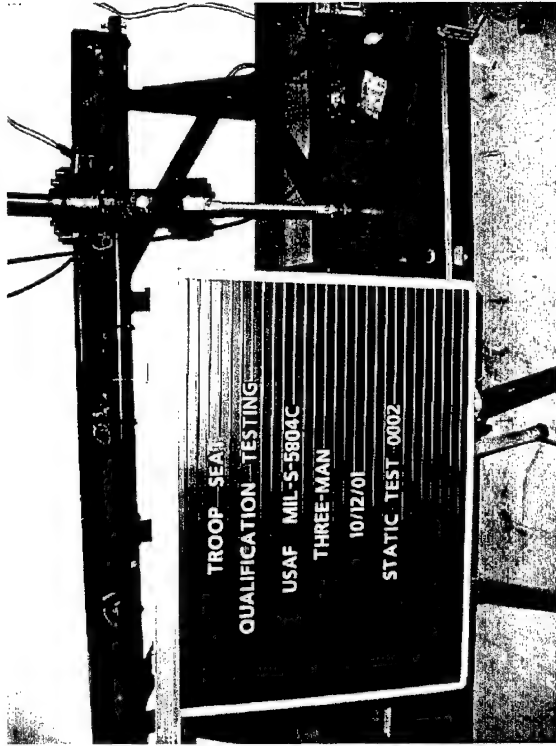
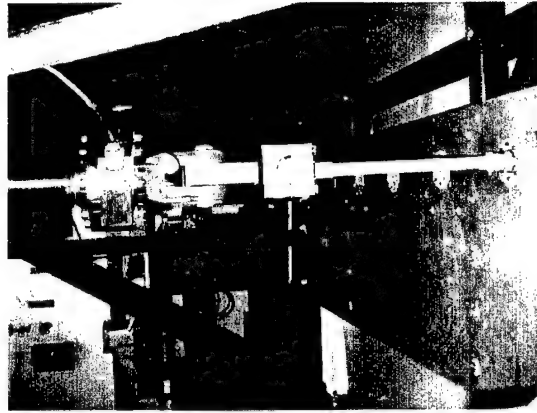
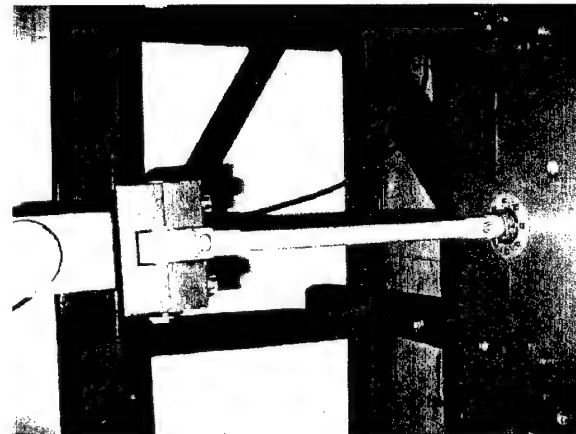
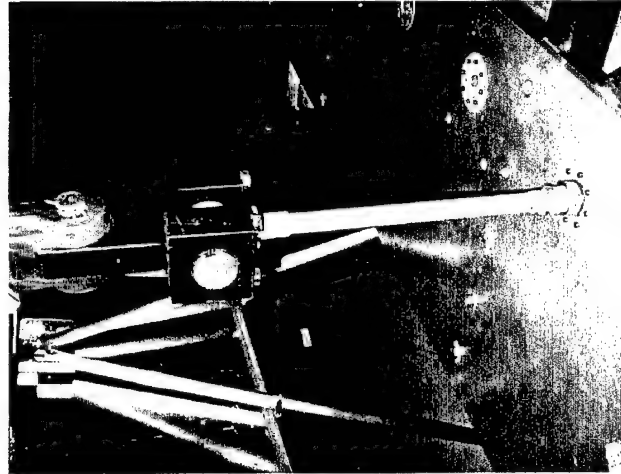
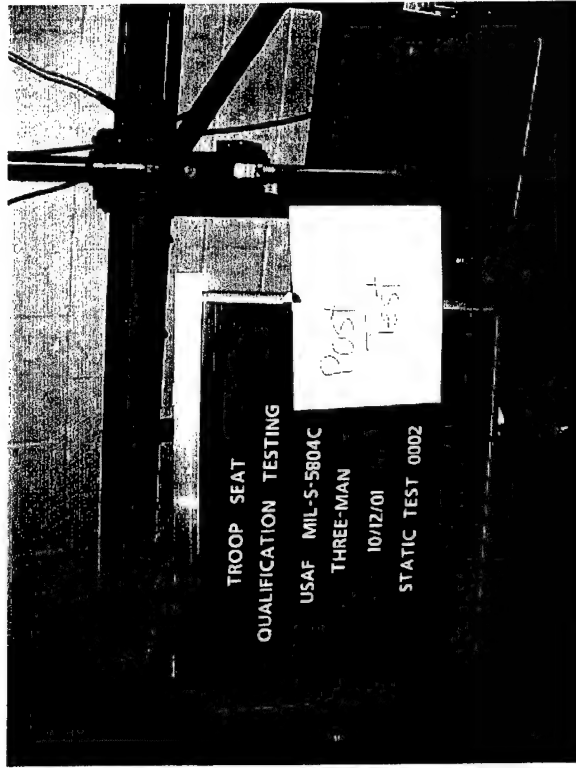
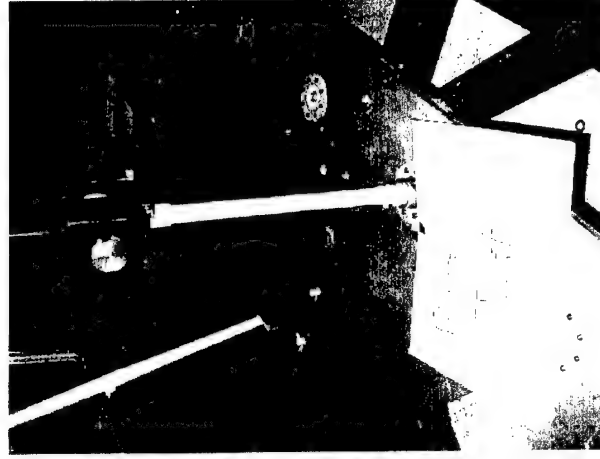
NOTES: This test went smoothly. The leg held the proof and ultimate loads. There was no deformation of the tubing or the locking device. The tube was the same length prior to and after the test. Still photographs show there was no damage to any part of the leg.

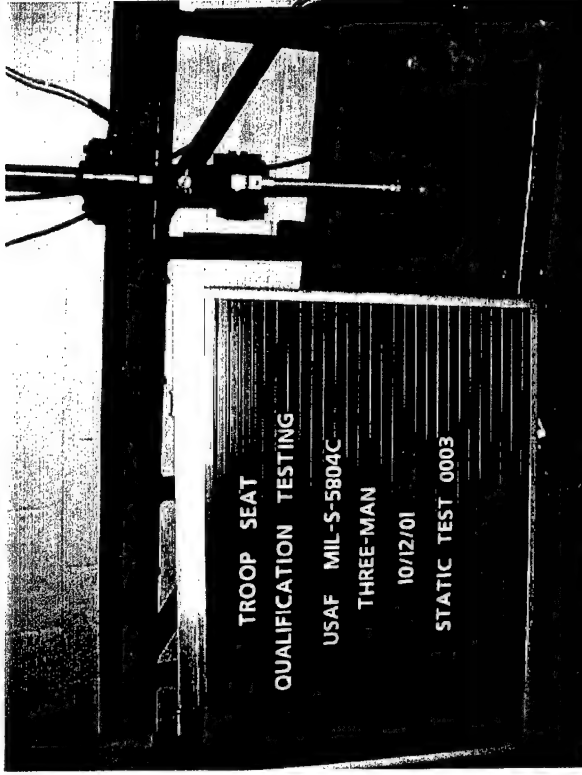
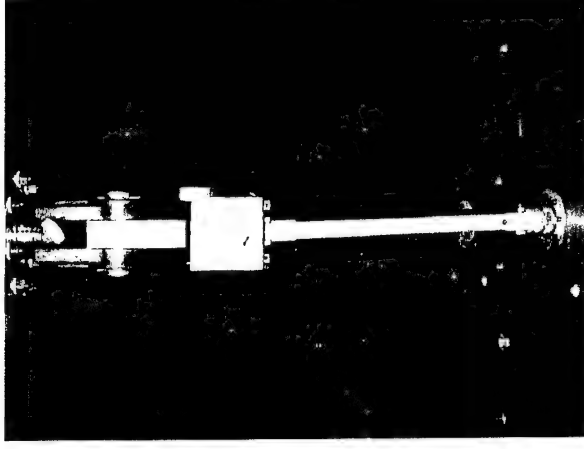
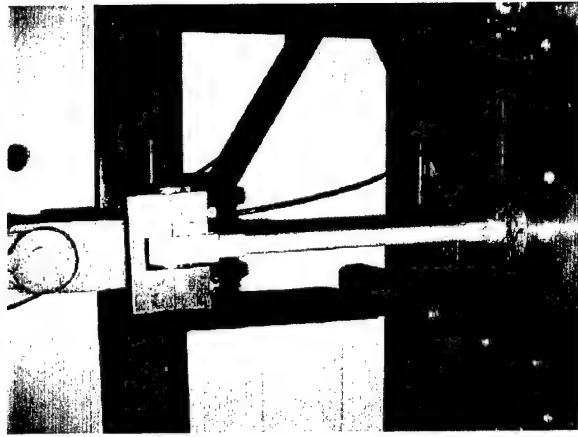
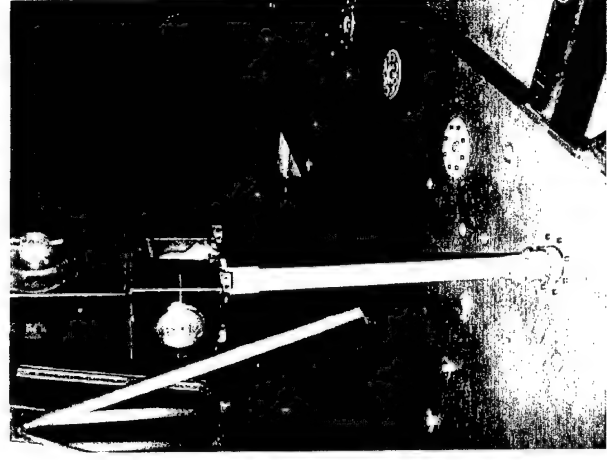
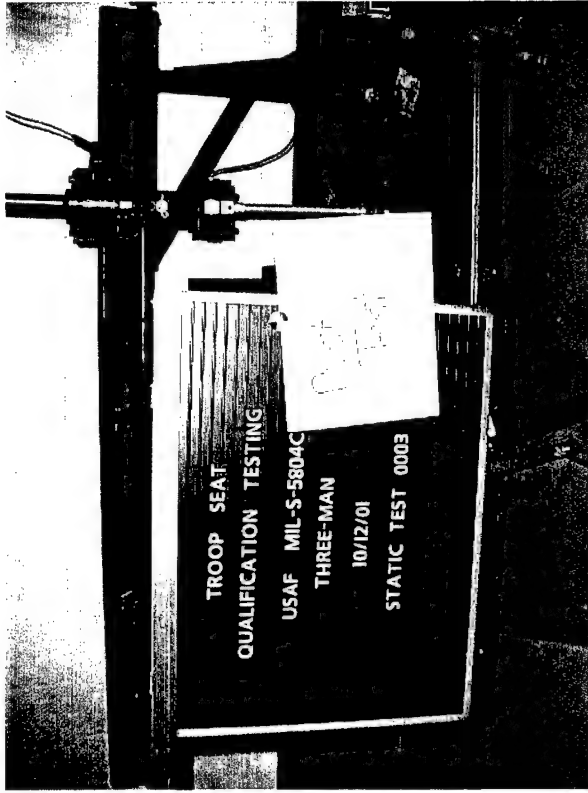
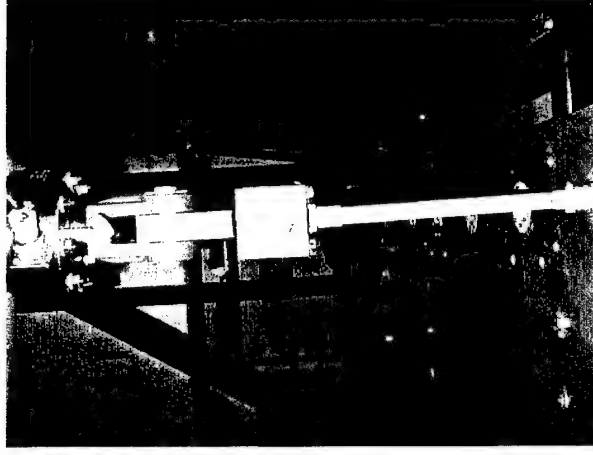
NOTES: This test went smoothly. The leg held the proof and ultimate loads. There was no deformation of the tubing or the locking device. The tube was the same length prior to and after the test. Still photographs show there was no damage to any part of the leg.

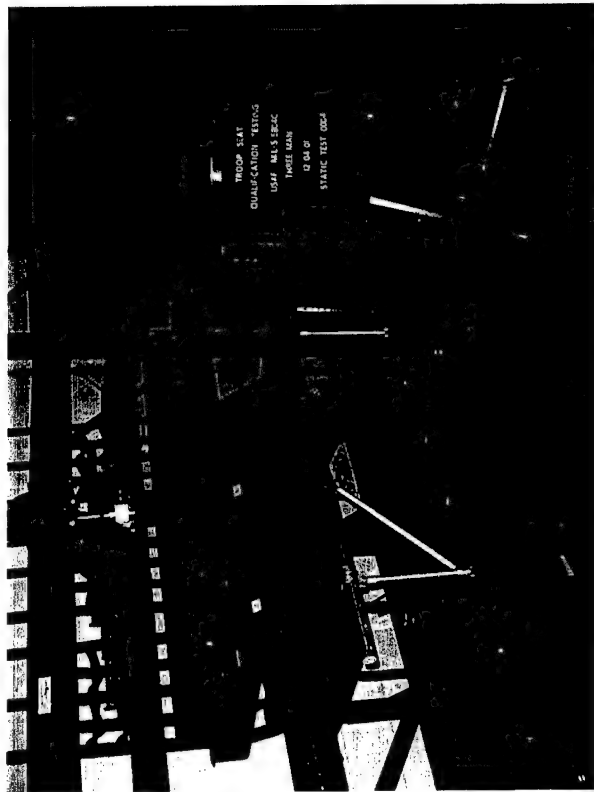
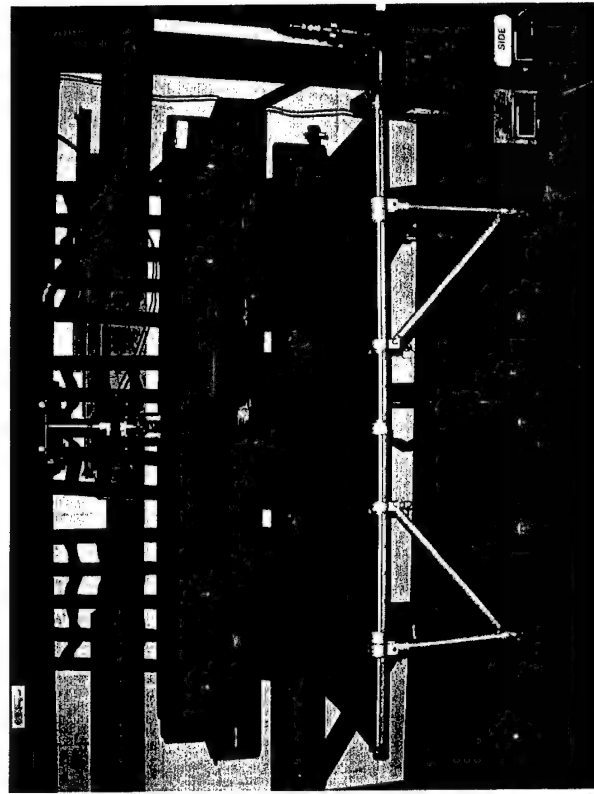
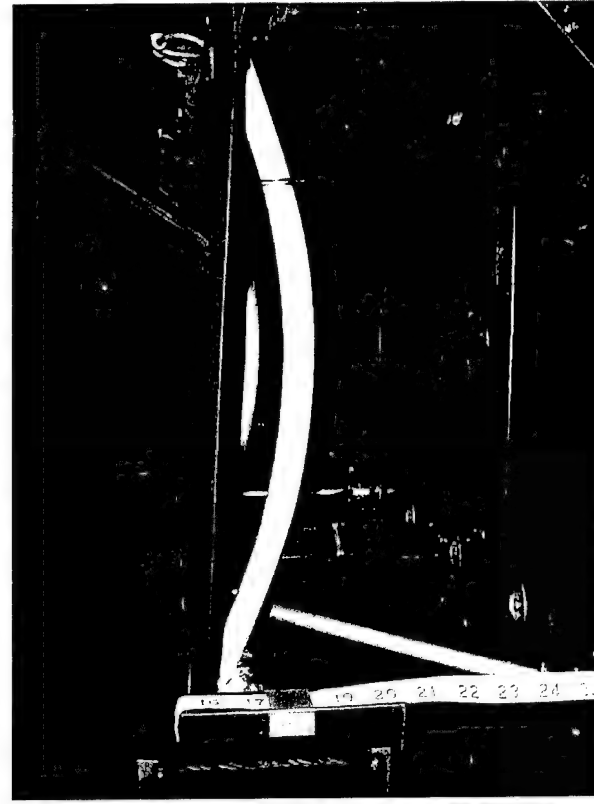
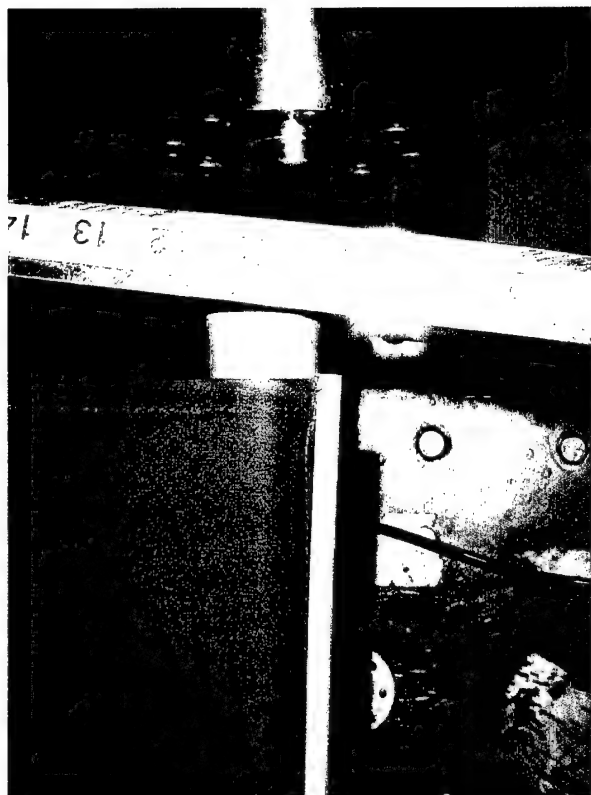
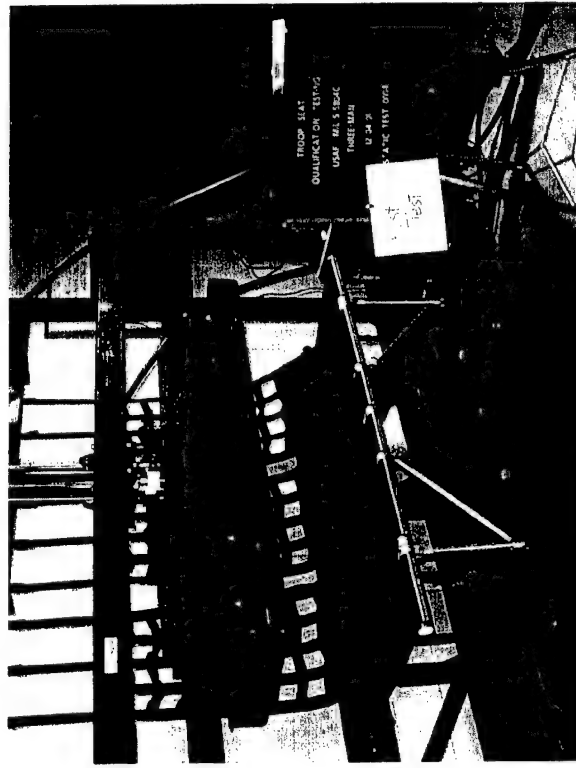
NOTES: LT Skaar was present for this test. There was difficulty releasing the right leg mechanism after the test, though no deformation was found in the mechanism.

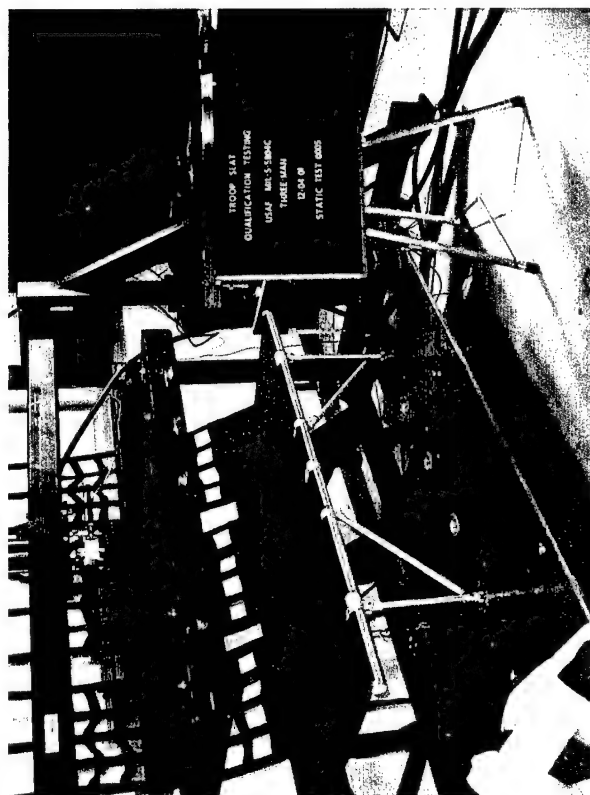
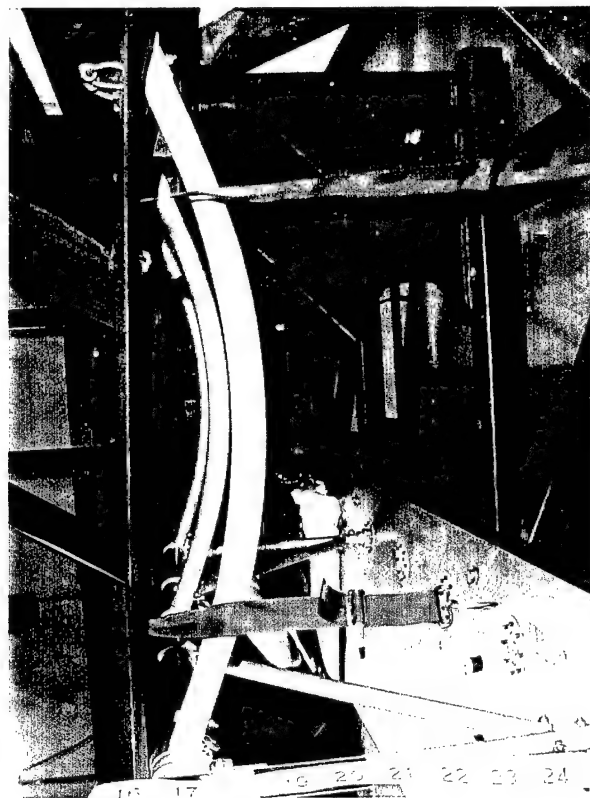
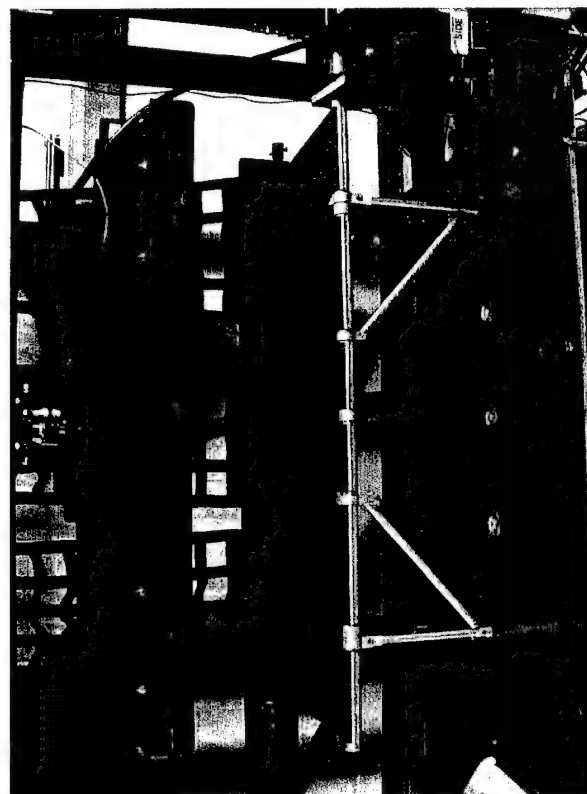
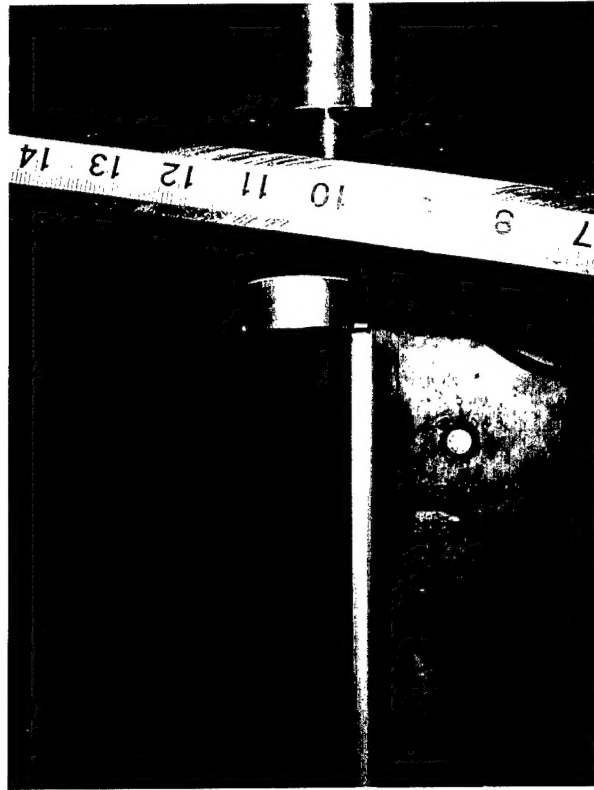
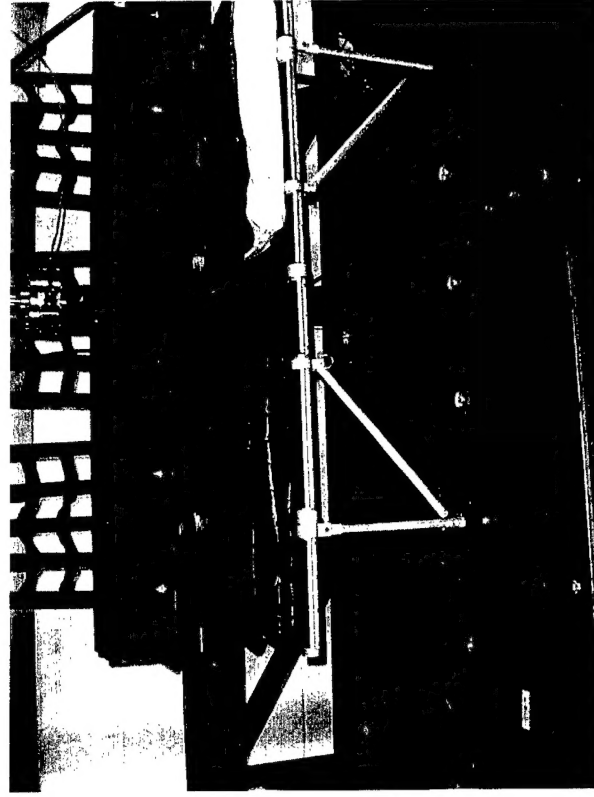
NOTES: LT Skaar was present for this test. After reaching the proof load for the side test, the right spreader bar failed. The seat failed prior to reaching the ultimate load for the seat bottom. The seat failure occurred at 5,240 lb. The floor plates deformed minimally during testing.
